1973 snapshot

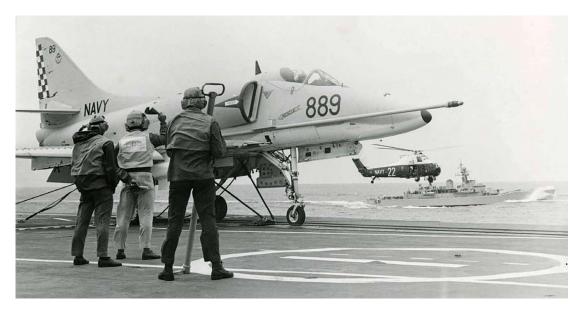
Skyhawk 889 which was lost on 8 November 1973 after a failed catapult launch. The shuttle is just behind the nosewheel, with the bridle being the two taut wires leading from it to the catapult hooks in the mainwheel wells. The holdback is the taut wire under the flaps at left, with the holdback restraint the two loose cables under it. The Flight Deck Officer is waving his green flag in his right hand. (FAAAOA)
